## **Wind Mitigation Report**

Dream Home Inspection Services, LLC.

123 Main Street

Uniform Mitigation Verification Inspection Form

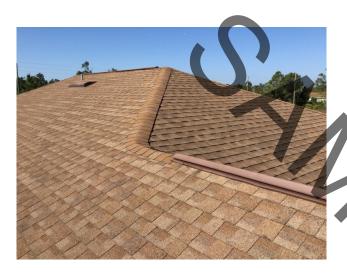
Roof Covering

1. Asphalt/Fiberglass Shingle 02/2	21/06 RES2005-22277	2006						
2. Concrete/Clay Tile/_								
3. Metal/_								
4. Built Up								
5. Membrane

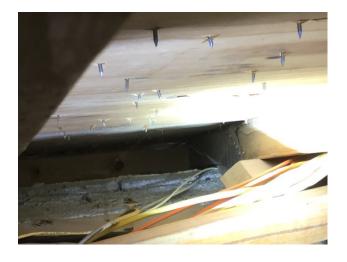
Truss Connection

B.	Clips								
				] Me	tal connectors that d	o not wrap over th	e top of the truss/	rafter, <b>or</b>			
	_			pos	tal connectors with a sition requirements o	minimum of 1 str f C or D, but is sec	rap that wraps over cured with a mini	er the top of the tru mum of 3 nails.	ss/rafter and does	not meet	the nail
	$\boxtimes$	C.	Single V		4-1	ating S and A	-t that	4h 4£ 4h		:	:41
				mir	tal connectors consinum of 2 nails on	the front side and a	a minimum of 1 n	ail on the opposing	side.	is secured	with a
